CARNEGIE-MELLON UNIVERSITY  
MELLON INSTITUTE

INVESTIGATION OF STRESS CORROSION CRACKING OF TITANIUM ALLOYS

Semi-Annual Progress Report No. 4  
for the Period  
December 1, 1967 through May 31, 1968

E. G. Haney and W. R. Wearmouth

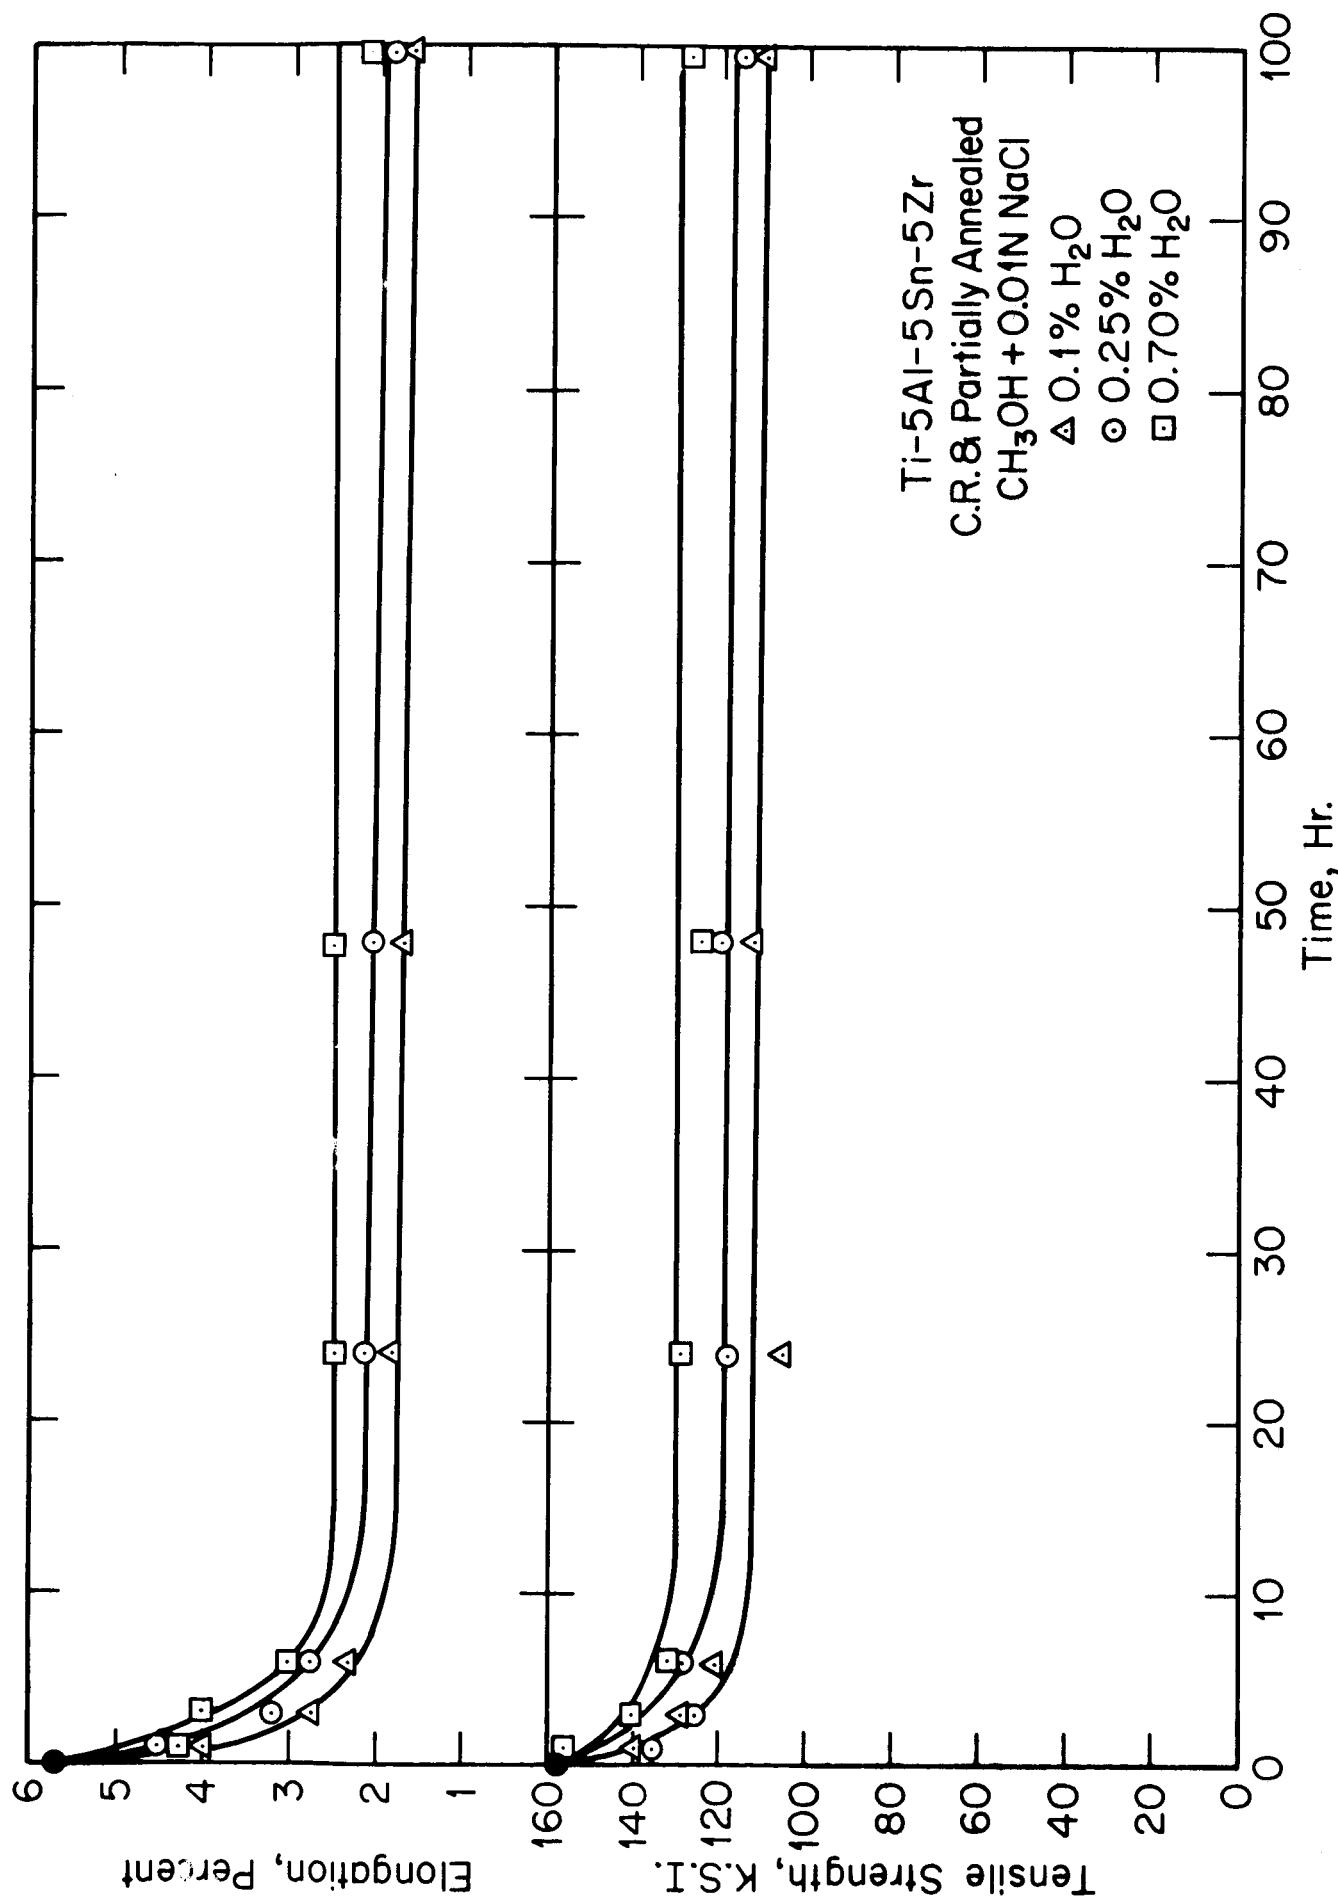
Figure 11 Deterioration of tensile properties in absence of stress.

Free Corrosion Tests - As previously mentioned, the cracking was characteristically brittle, and, apart from the actual cracks, metallographic examination showed no signs of any chemical attack in the form of general pitting or selective corrosion. In fact, the metal surface remained in the same condition as it was prior to immersion, i.e., bright and untarnished. To try to understand the corrosion processes occurring, the behavior of the alloy under freely corroding conditions in the absence of applied stress was studied. The effects of corrosion were ascertained from the deterioration in the tensile properties of the alloy after having been exposed to the solution for varying times. The solution compositions used were the same as those used previously to determine crack propagation rates and the results are shown in Figures 11 and 12.

From these graphs, it is evident that the acid solution is far more aggressive, particularly at the low water contents. In fact after 100 hours immersion in the  $\text{CH}_3\text{OH}/0.01 \text{ N HCl}/0.1\% \text{ H}_2\text{O}$  solution, it was impossible to handle the specimen without it disintegrating. On metallographic examination of such specimens, the grain boundaries were found to have become delineated as well-defined black lines. Due to handling, many "cracks" were found, as shown in Figure 13(a) and (b).

Figures 11 and 12 also show that the tensile properties deteriorate uniformly as the water content is increased and the solutions corresponding to the minima in the time to failure curves do not cause the most deterioration. Therefore, it is apparent that the latter solutions have their attack greatly enhanced only when the specimens are exposed under stress.

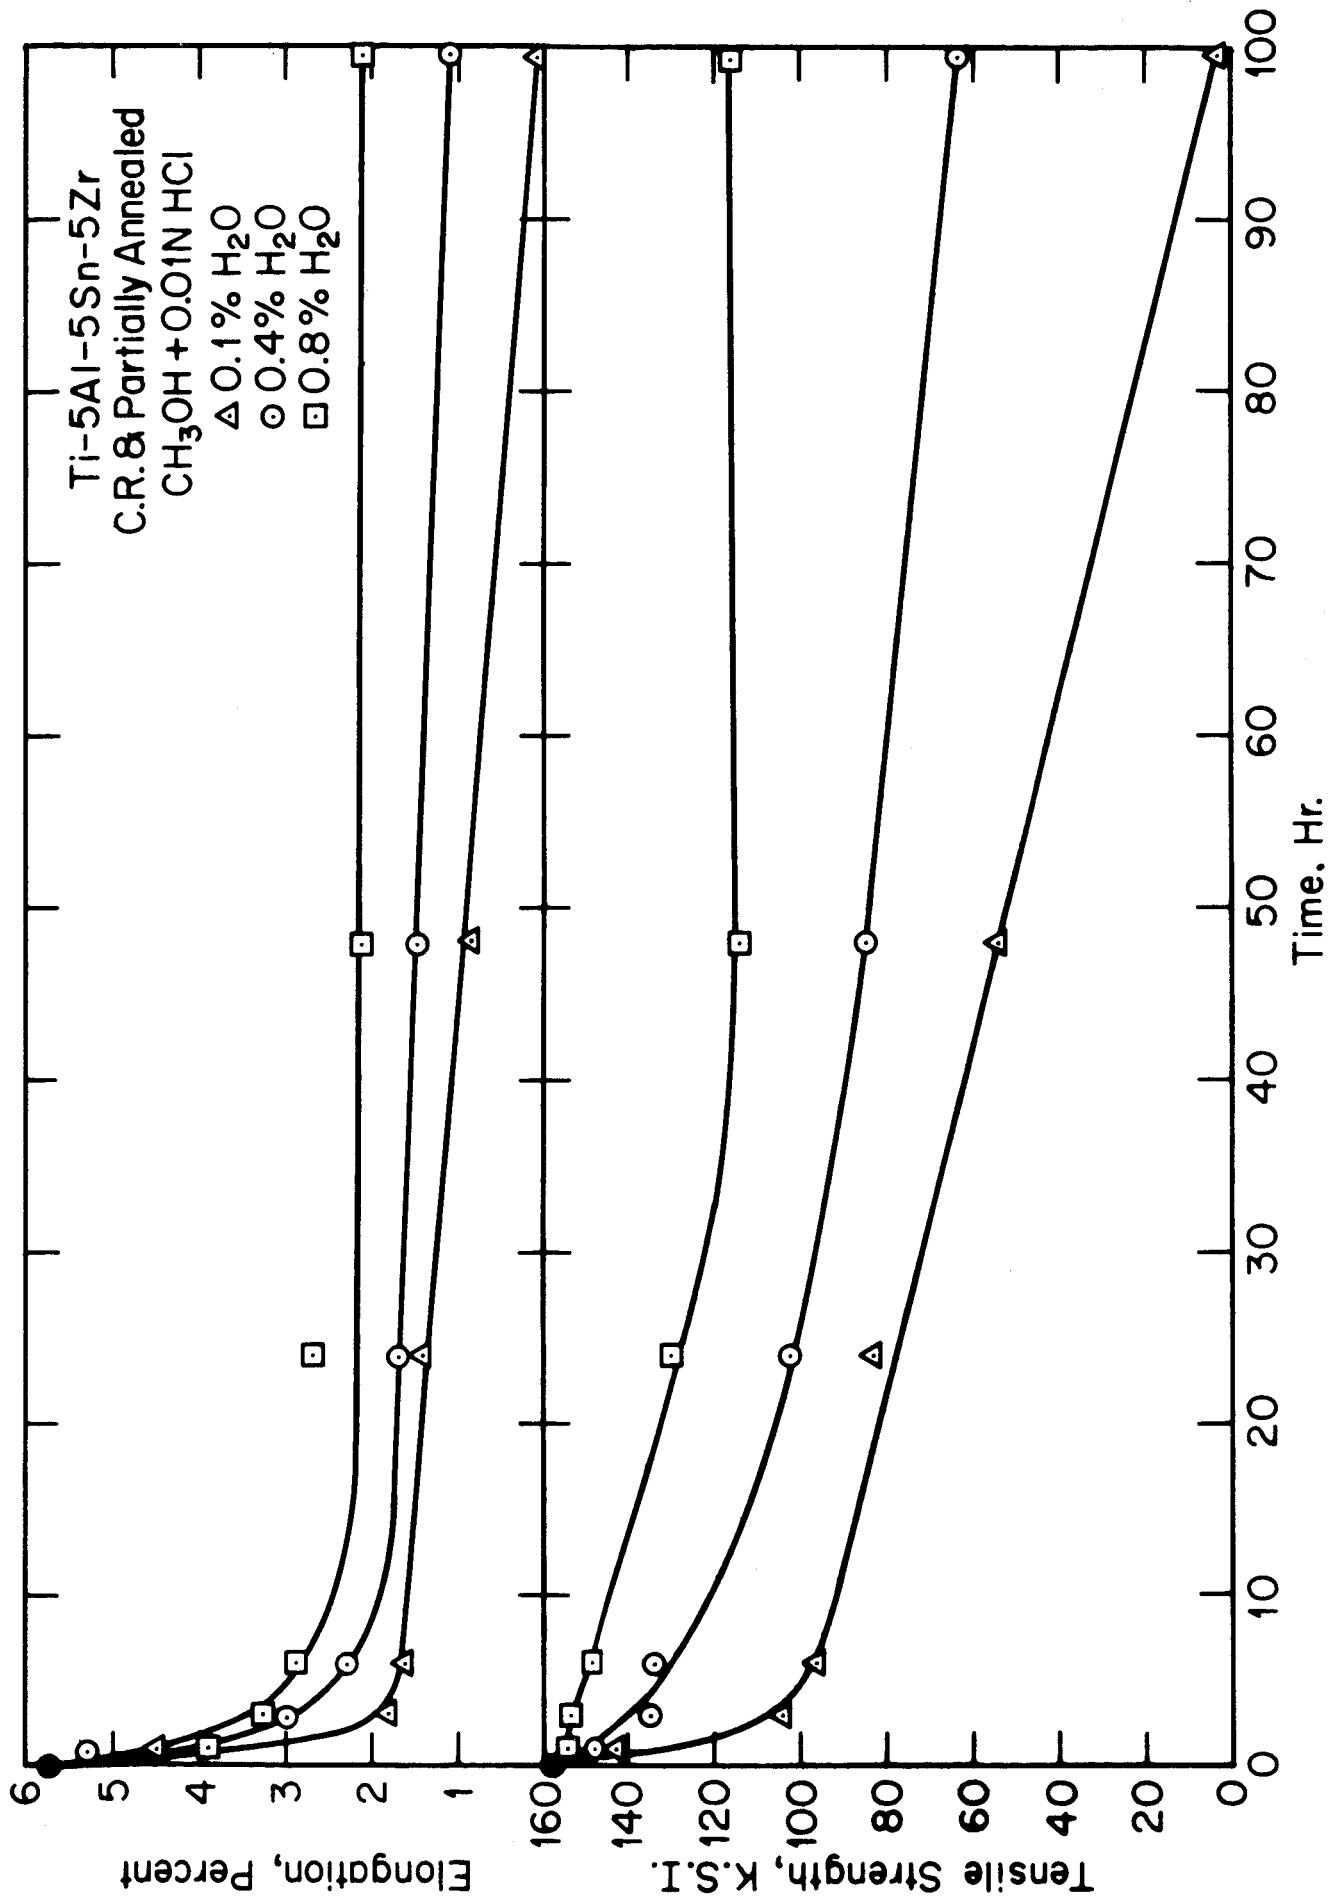
Figure 12 Deterioration of tensile properties in absence of stress.

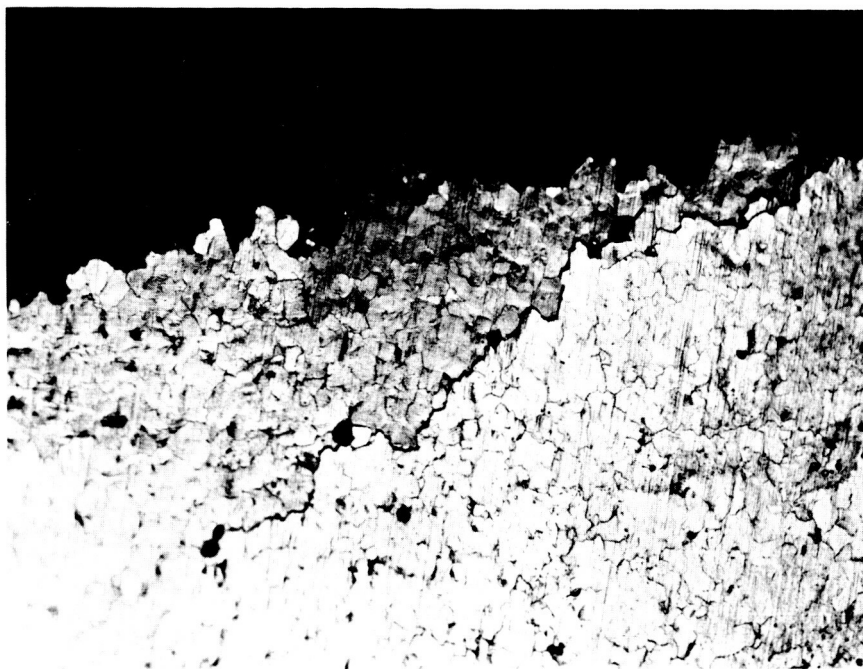
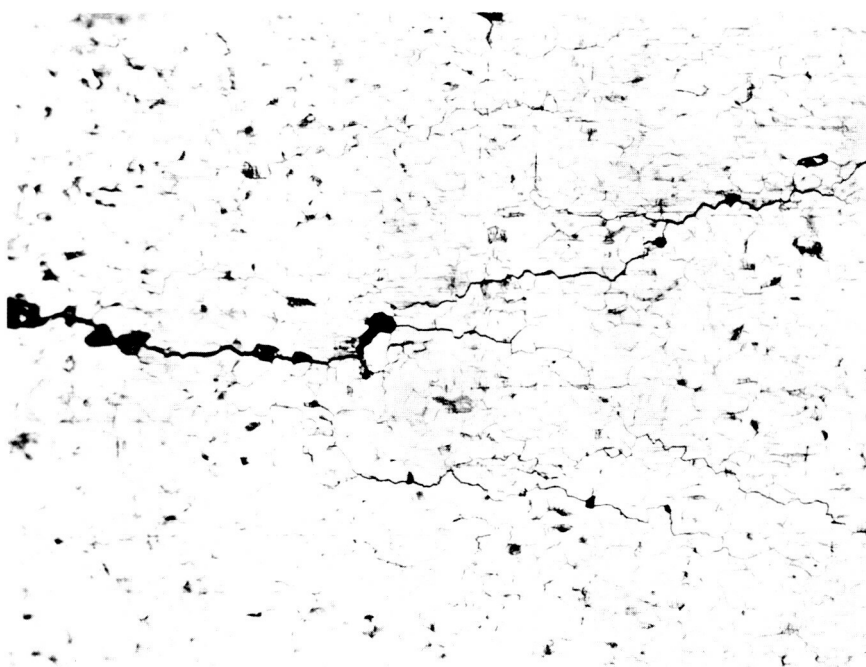
Figure 13 Intergranular disintegration in Ti-5Al-5Sn-5Zr, after 100 hrs.  
immersion in  $\text{CH}_3\text{OH} + 0.01\text{NHCl} + 0.10\% \text{H}_2\text{O}$  without stress.  
Unetched 80X

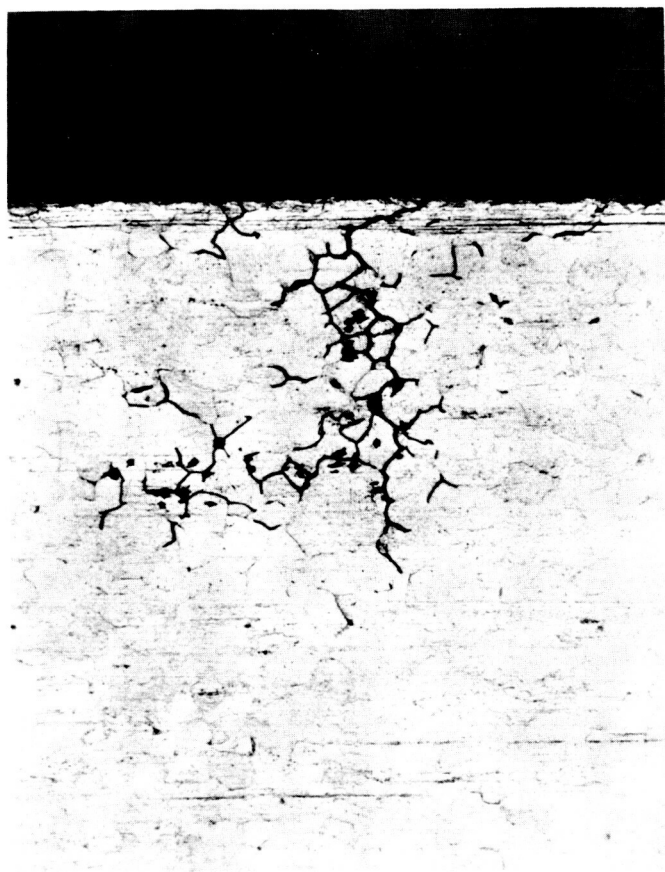
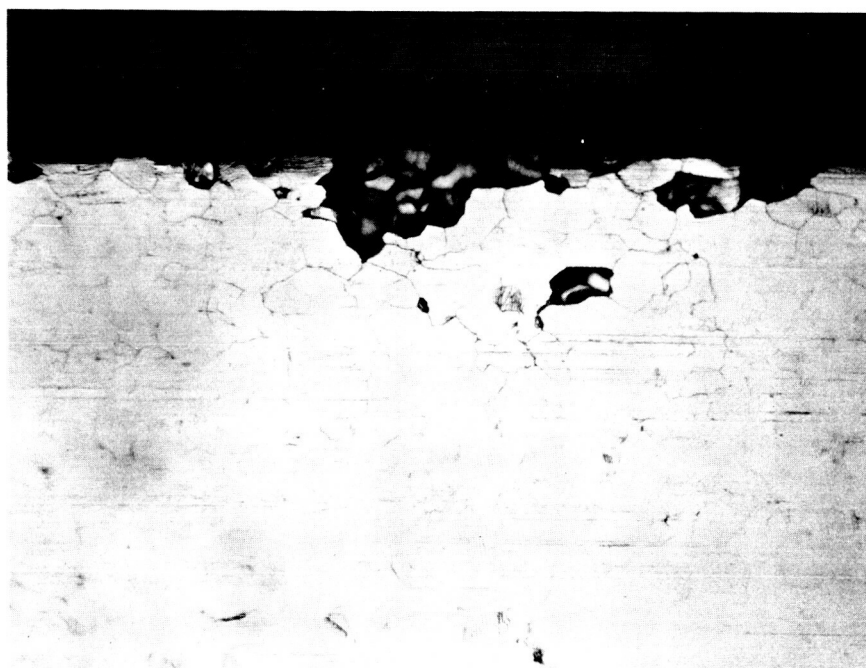
Figure 14 Intergranular "cracking" in Ti-5Al-5Sn-5Zr tensile tested in air after 6 hours immersion in  $\text{CH}_3\text{OH} + 0.01\text{NHC1} + 0.10\% \text{H}_2\text{O}$ .  
Etched 160X

In specimens examined after being tested to determine residual tensile properties, "cracks" were found, much the same as in specimens stressed while immersed, i.e., intergranular, but containing a lot more associated cracking, Figure 14(a) (c.f., Figure 6). Also, whole grains were found to have fallen out (Figure 14(b)). From the metallographic evidence, it would appear that, rather than corroding, embrittling would be a far more realistic and accurate description for the effect of methanol solutions on the alloy.

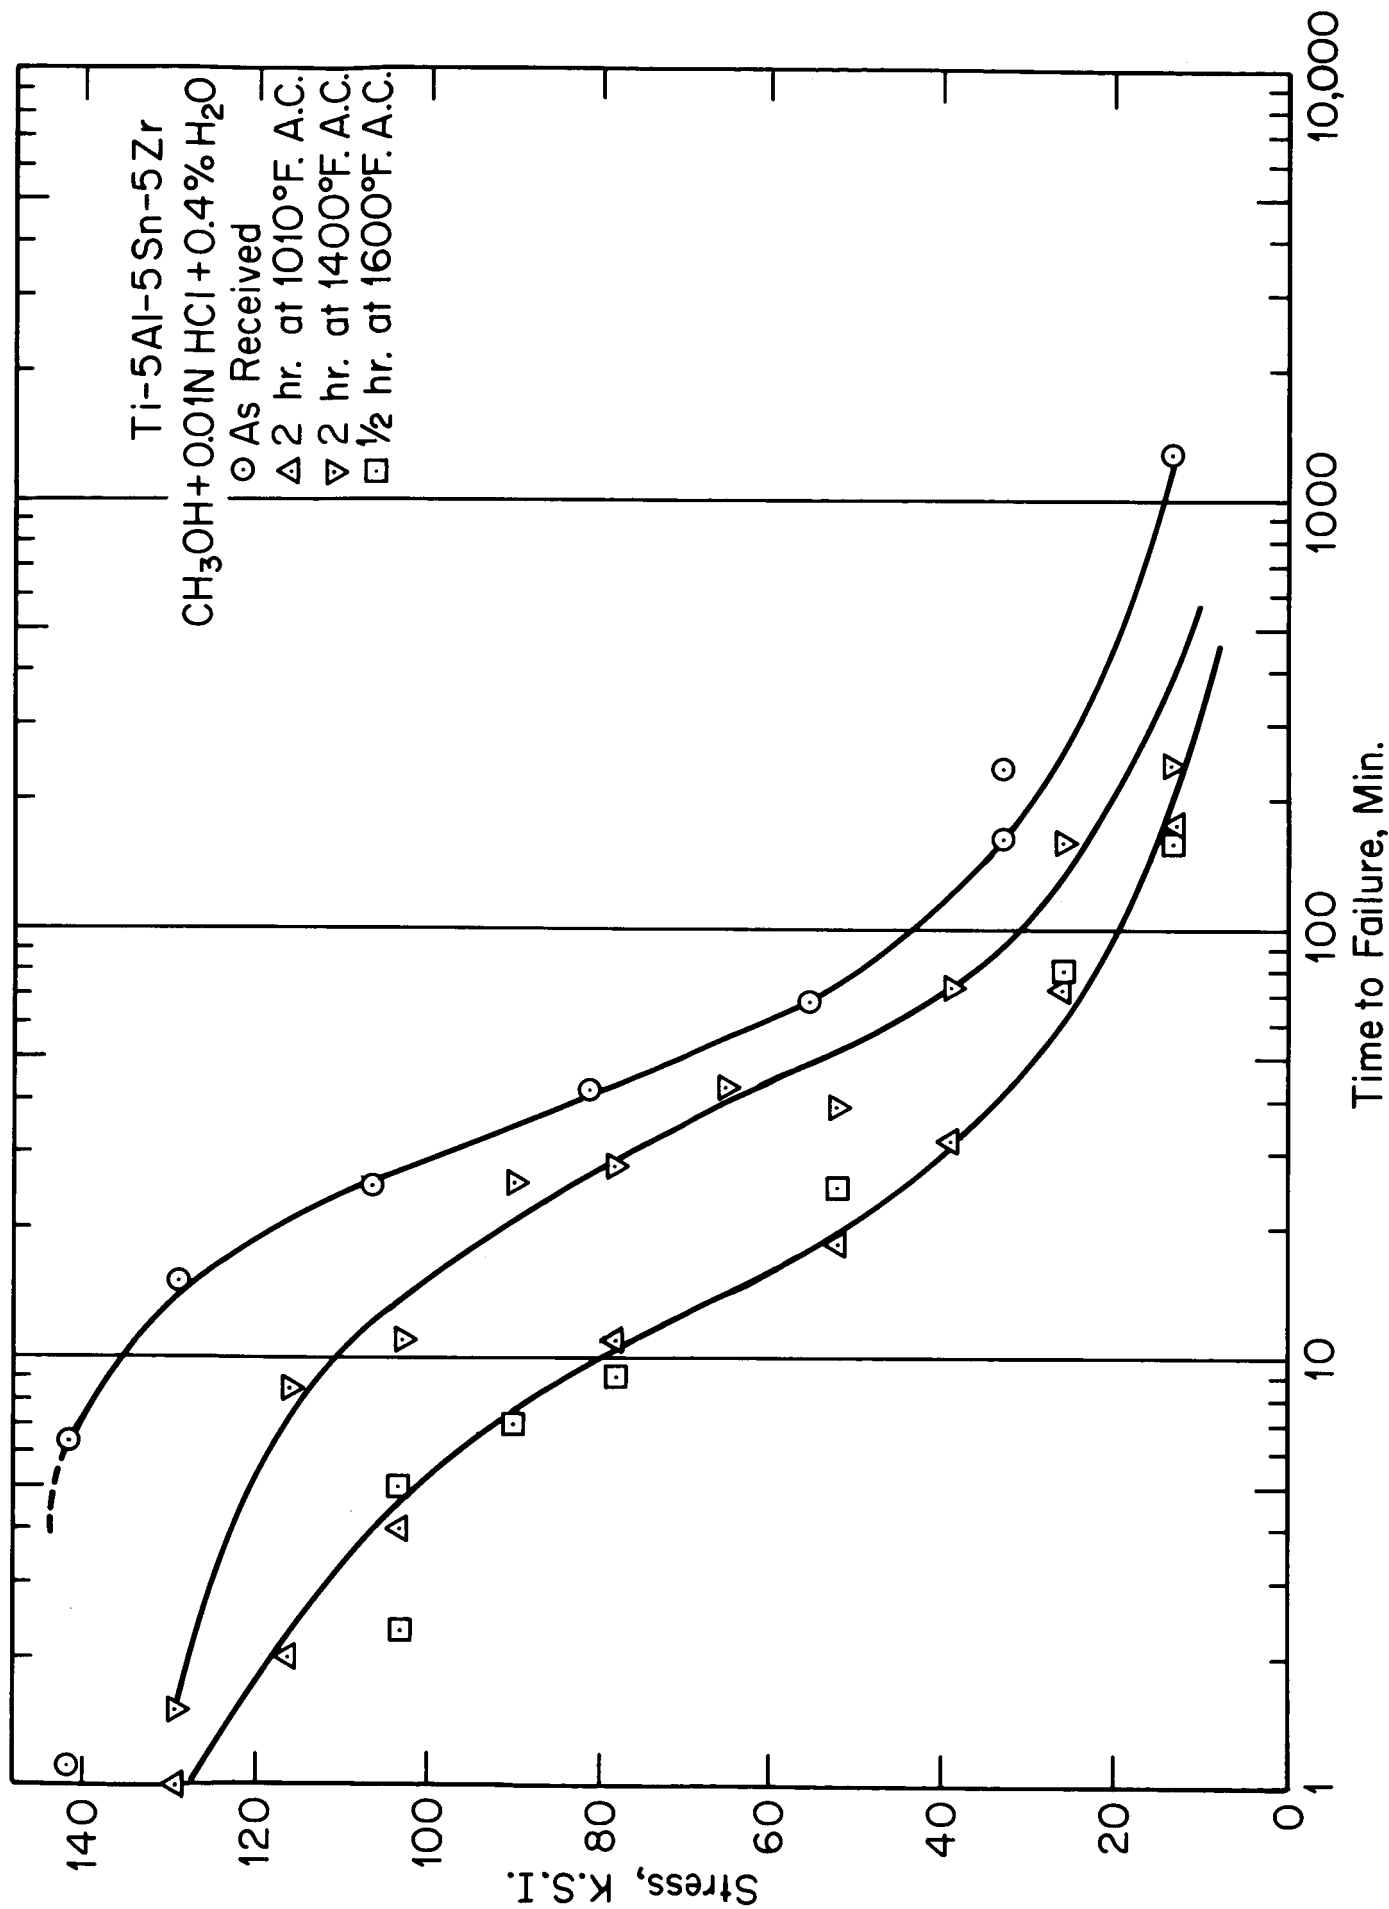
Figure 16 Effect of heat treatment and applied stress on time to failure.

Curves of applied stress versus time to failure for a given solution (Figure 16) were found to be similar in shape to the curves for the as-received material, the marked decrease in the failure times occurring at lower stresses probably because of the lower yield strengths of the heat-treated material. However, it is worthy of mention that for a given stress the times to failure do not decrease uniformly with increasing heat treatment temperatures but that the 1600°F and 1010°F heat treated specimens are more susceptible than the 1400°F heat treated specimens.

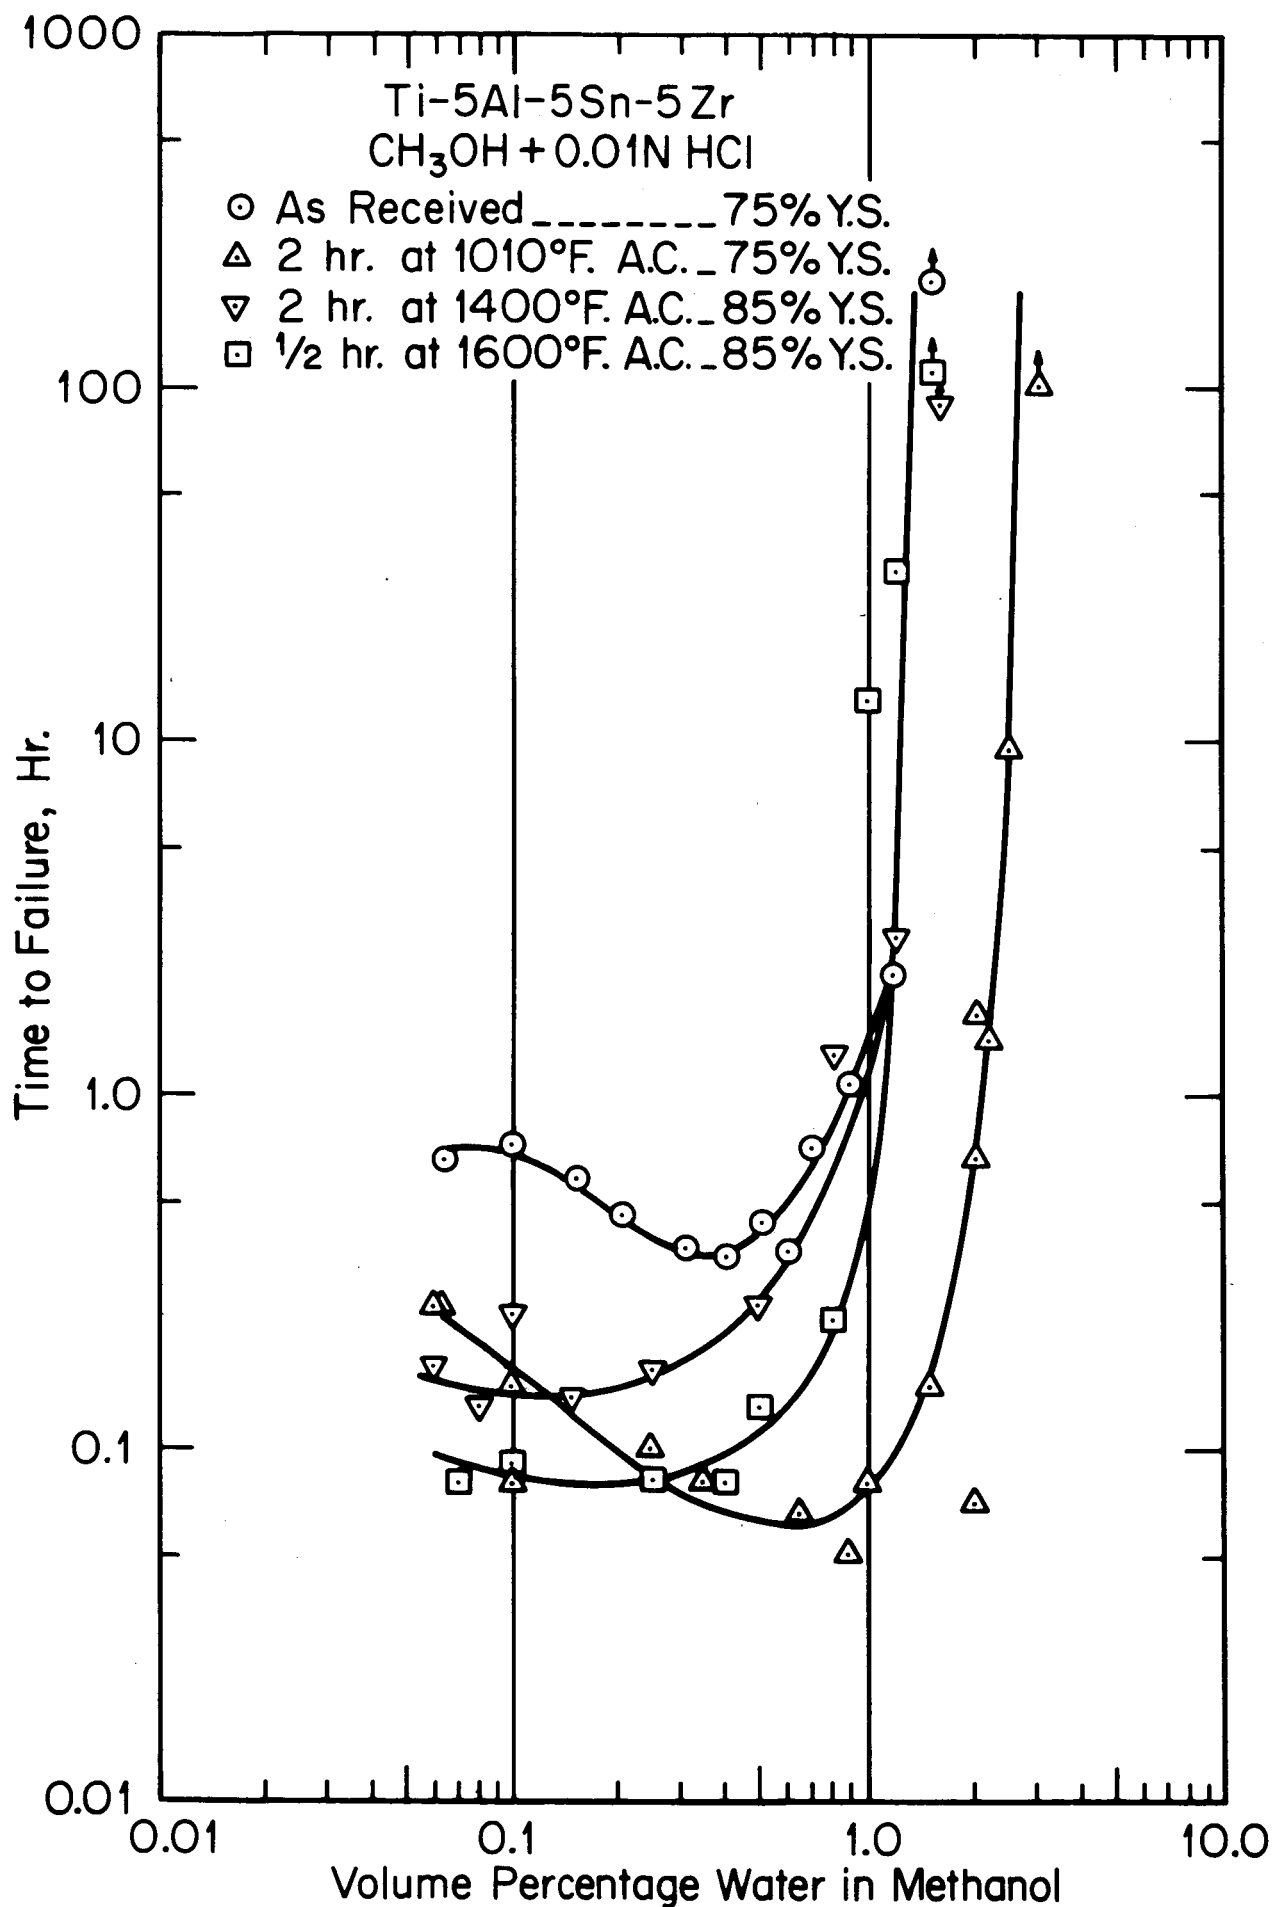
Figure 17 Effect of heat treatment and solution composition on time to failure.

Using the same heat treatments, the variation in failure times with water content of the  $\text{CH}_3\text{OH}/0.01 \text{ N HCl}$  solution was studied and the results are shown in Figure 17. The relative susceptibilities to cracking are seen to be dependent upon the water content of the methanol as well as upon the heat treatment. Also, 3% water is needed to inhibit cracking in the 1010°F heat treated specimens, whereas 1.5% water is sufficient for

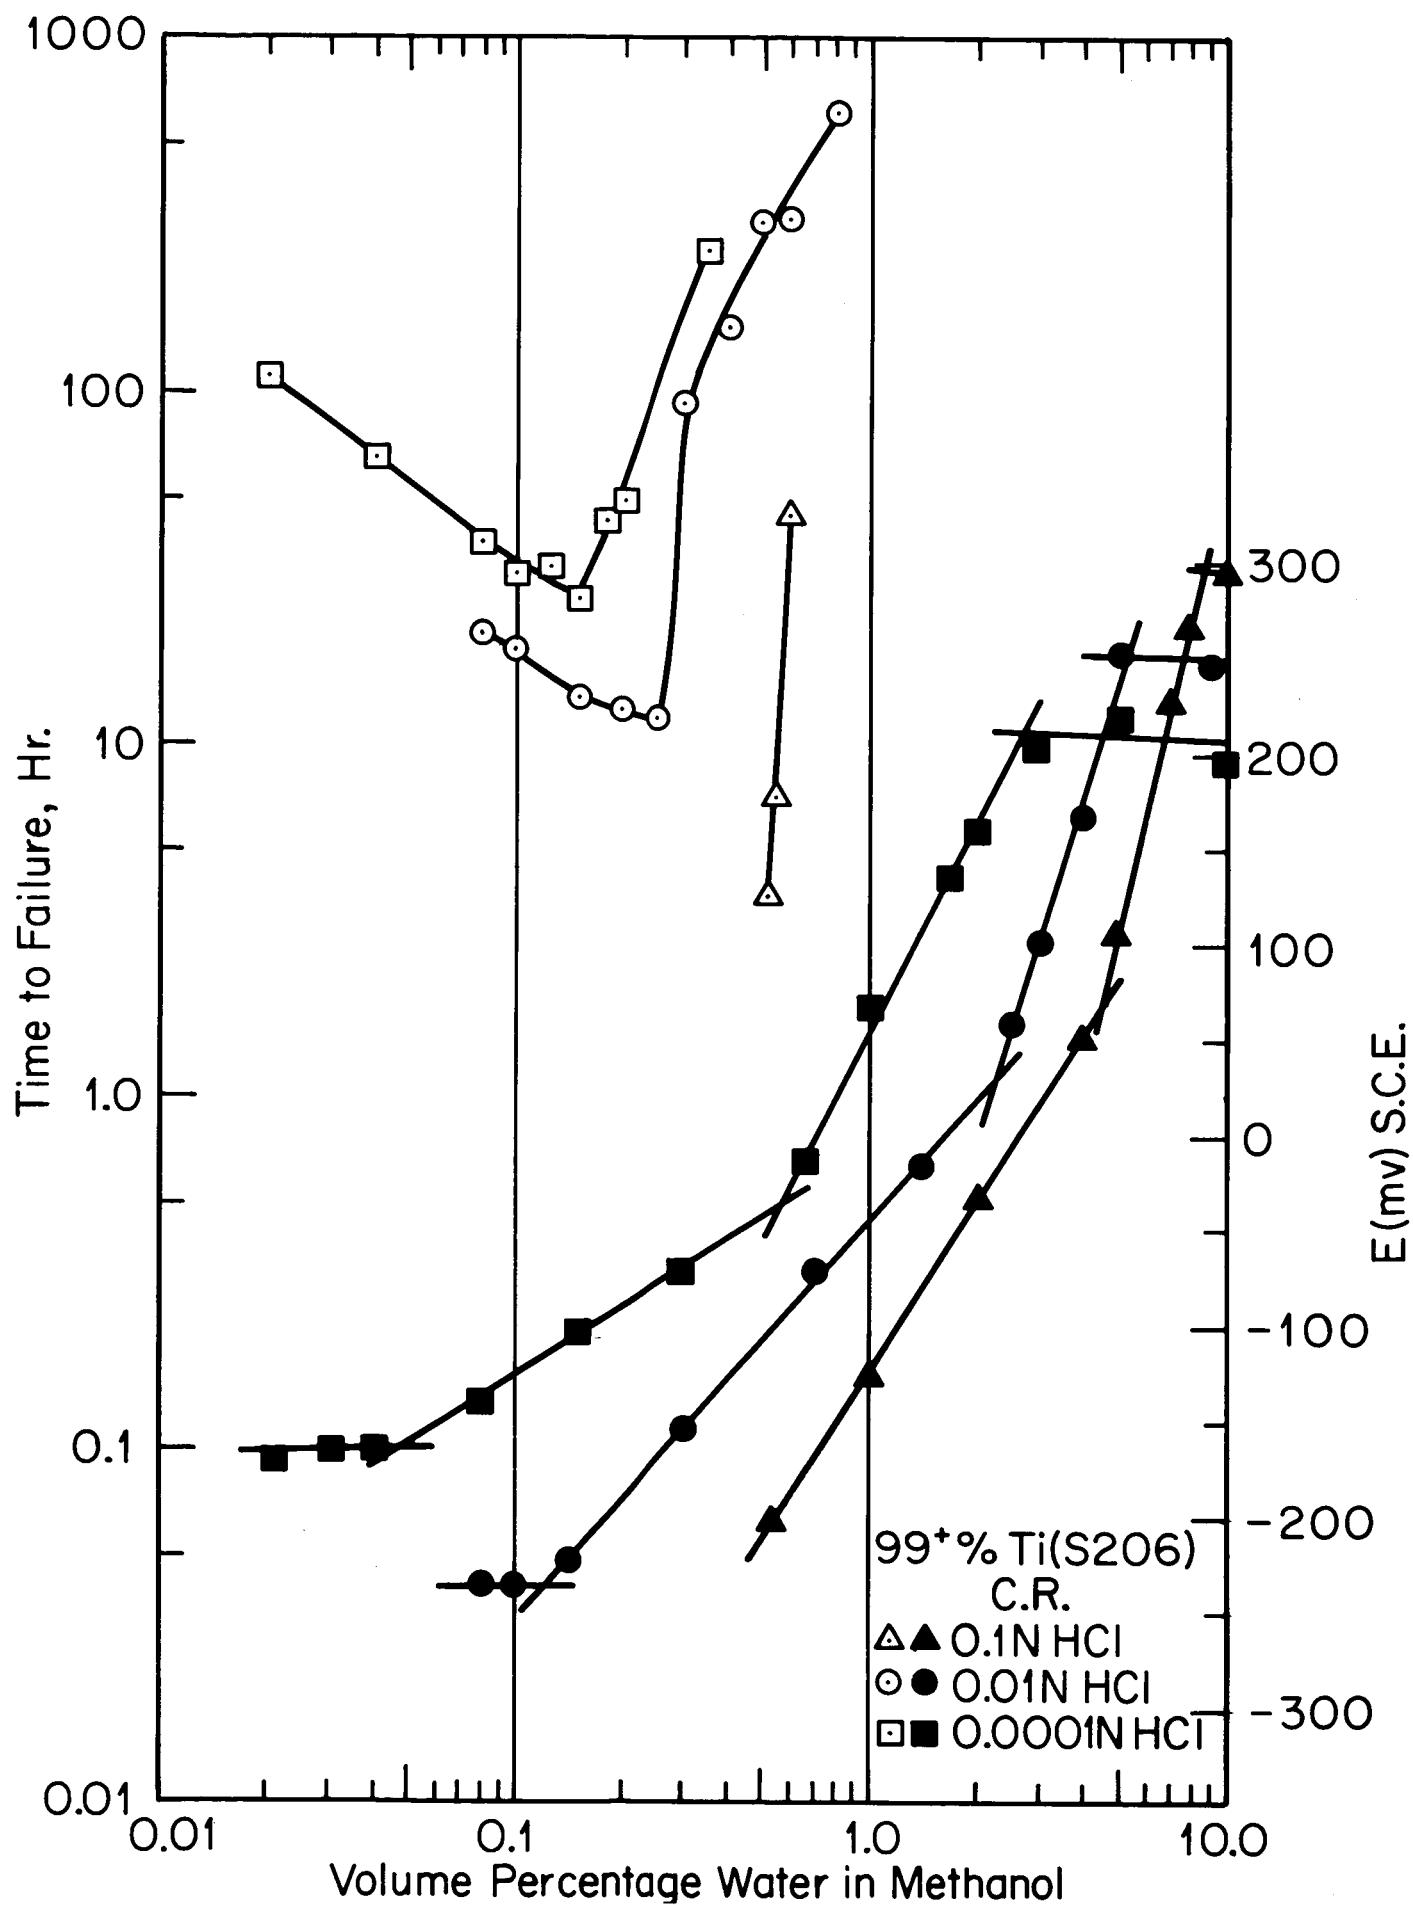
Figure 18 Comparison of time to failure with one-hour electrode potential values.

An extensive investigation was made with 99<sup>+</sup>% Ti foil (S206) comparing the effects of adding water or certain organic liquids to methanol. The chloride ion was added as HCl in preference to NaCl because the solubility of NaCl in most of the organics of interest is limited. Figure 18 presents the results for the water addition at three

levels of HCl content. The higher the HCl content, the more water was necessary to stop the cracking and the deeper was the minimum in the time to failure curve. This is similar to what has been found for other alloy foils and noted in Semi-Annual Reports Nos. 2 and 3. The water carry-over from the HCl additions limits the investigations of lower water contents.

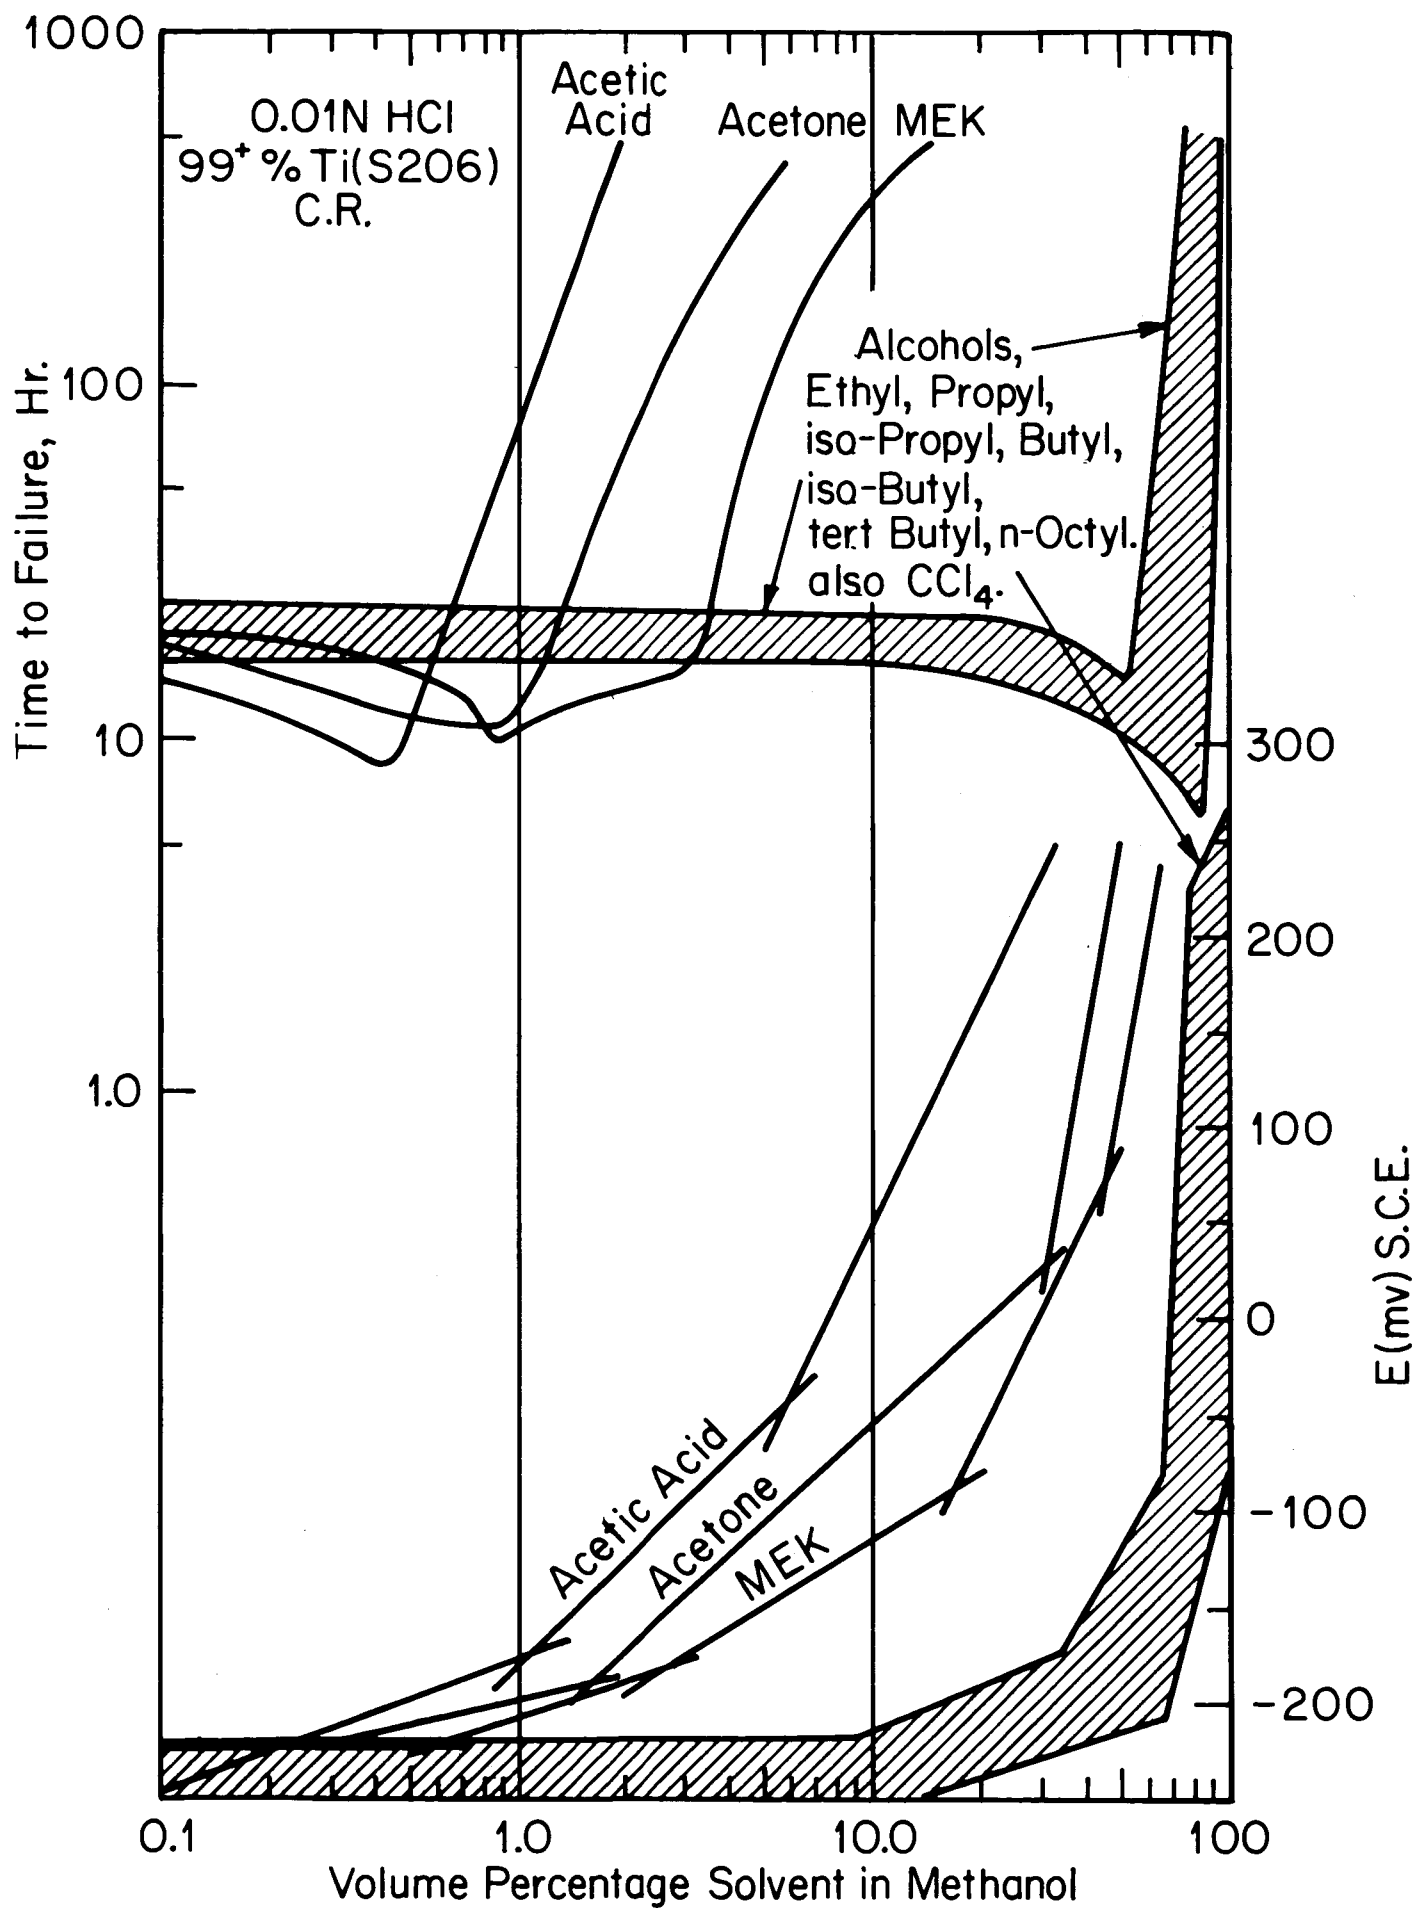
Figure 19 Comparison of time to failure with one-hour electrode potential values.

The time to failure and corresponding electrode potential measurements are shown in Figure 19 as a function of the organic liquid added to the methanol. The data points for the alcohols and carbon tetrachloride fell into a fairly narrow range up to at least 60% of the addition and are represented as a band. The alcohols were not as effective in preventing cracking of the foil as acetone, methyl ethyl ketone (MEK), or acetic acid. The electrode potential measurements would predict such behavior. In no instance did any cracking occur within 500 hours without at least a few percent of methanol present.

The water content alone can account for the apparent inhibiting effect of acetic acid, acetone, and MEK as shown in Figure 19 and comparing with Figure 18. Additional proof of the effect of water can be seen in Figure 20, which compared HCl with NaCl as additions. Note the water content differences for 10% MEK in the table. However, do alcohols prevent cracking by any reactions involving water. It seems doubtful, because the amount of water in n-octyl alcohol is about the same low water at 20% and 90% (see table). At the 20% n-octyl alcohol level, the foil was easily cracked; but the foil did not crack in 500 hours at the 90% level. The curves for 2-propanol have similar shapes whether NaCl or HCl was used (see Figure 21), again indicating no reactions involving water.

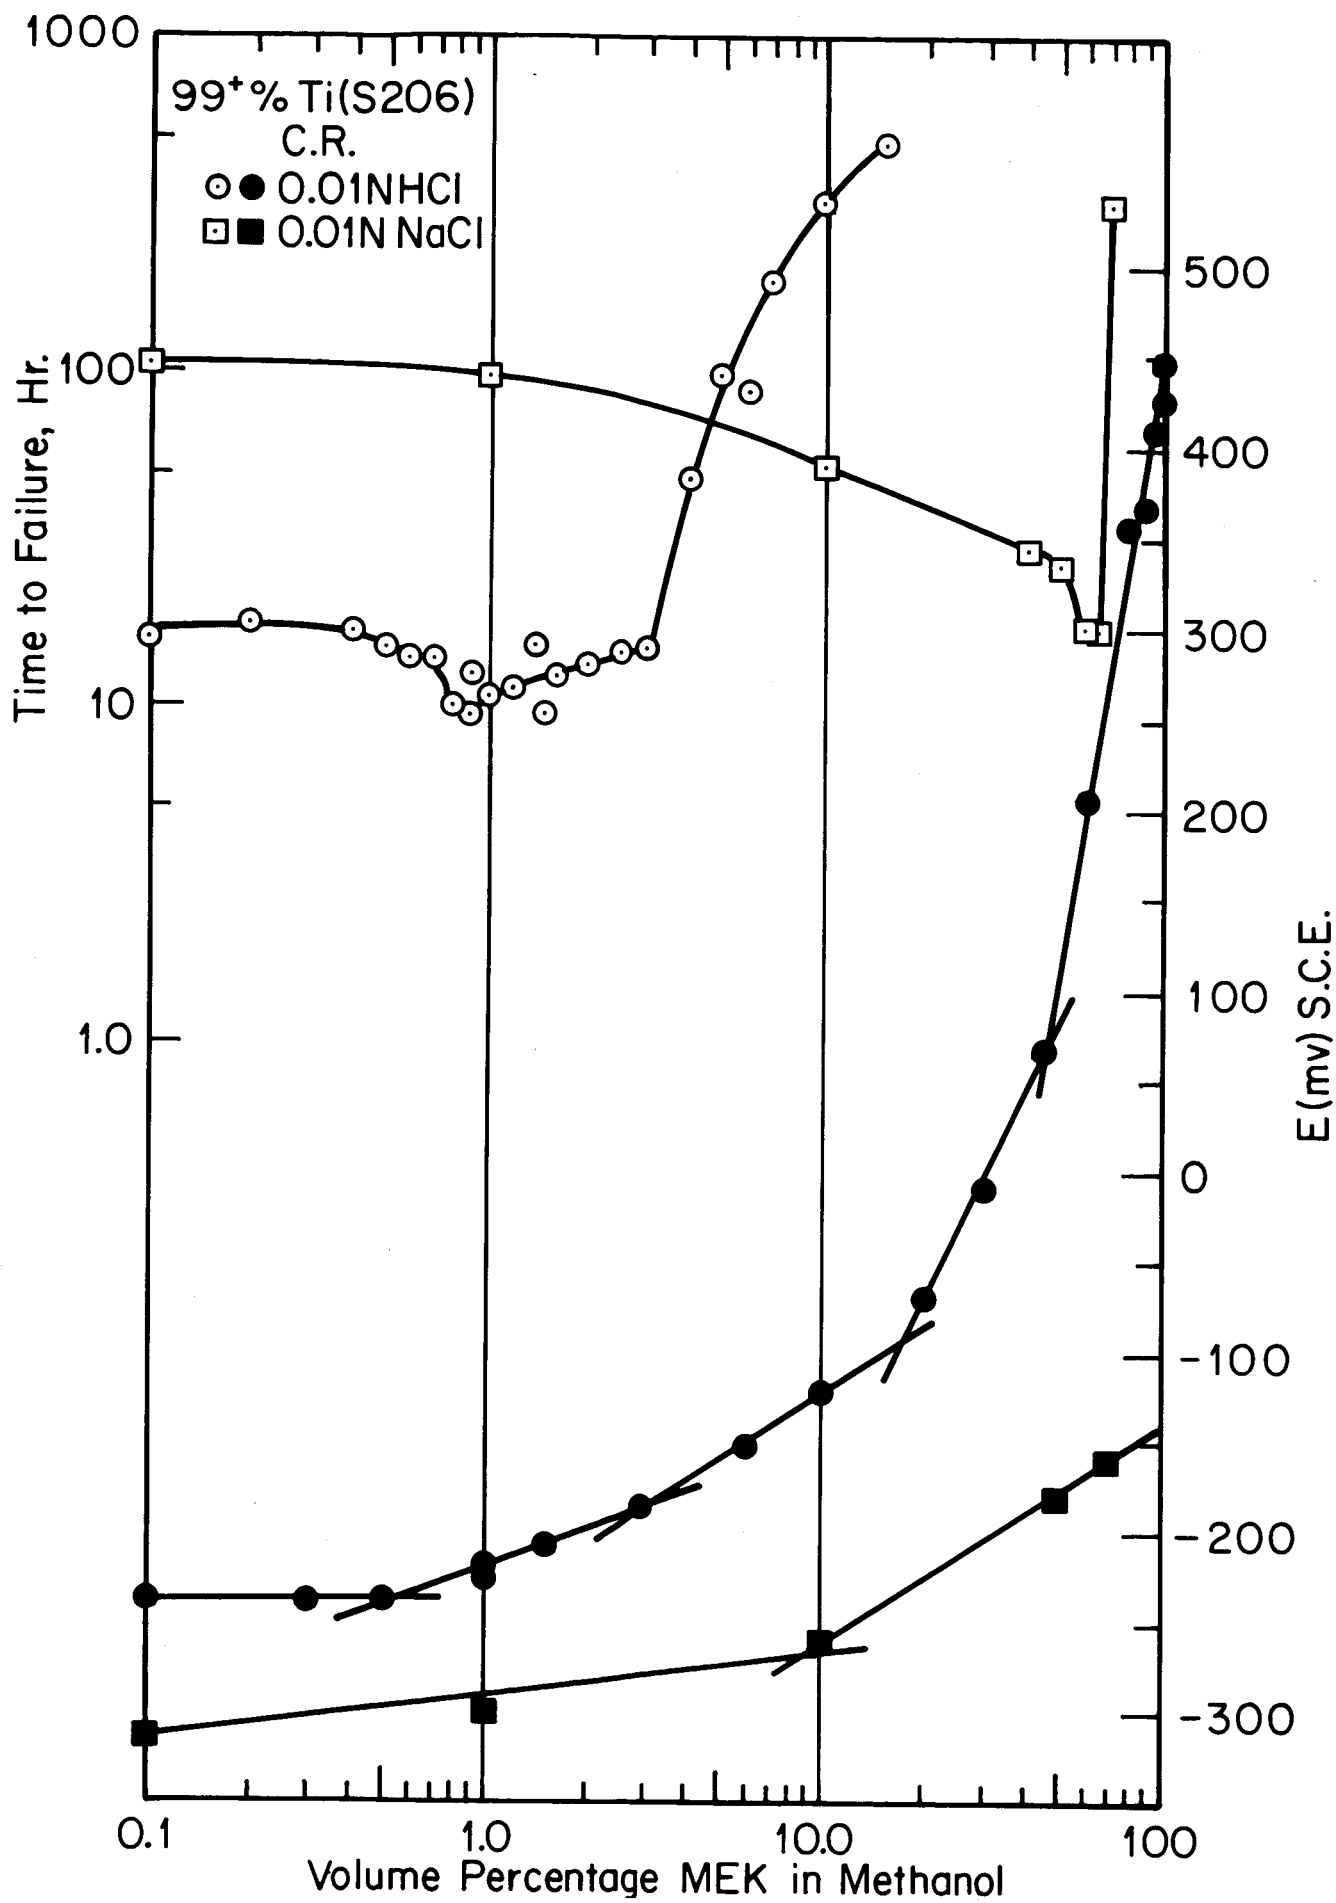
Figure 20 Comparison of time to failure with one-hour electrode potential values.
